## Removal of broken endodontic instrument using Ultrasonic's and Magnifying loupes – A case report

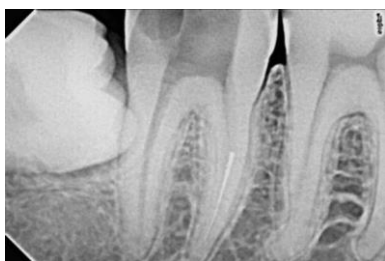
**Fig. 1: Preoperative Radiograph showing separated instrument in the middle third of mesiobuccal canal of right mandibular second molar**

In the first appointment, Patient's informed consent was obtained. Under local anesthesia and optra dam isolation, caries were removed and access cavity was modified and canal orifices were located using DG16 explorer & a straight line access was created by Gates Glidden drills. Obstruction to canal was felt when k file No. 15 was introduced into the.... canal but with the help of magnifying loupes exact location of the coronal end of the separated instrument could be appreciated in the canal. After that No. 10 K file was inserted passively and advanced only 1mm at a time with copious amount of irrigant (5.25% NaOCL) and after a given insertion if K file comes out of the canal bent or deformed it was discarded.

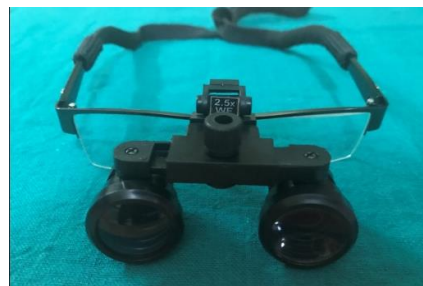
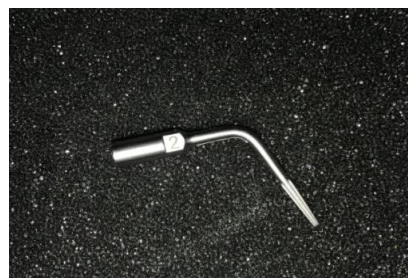
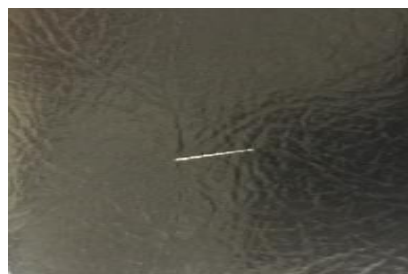
**Fig. 2: Magnifying loupes and ultrasonic's which were used and Clinical image of the retrieved broken instrument**

Ultrasonic tips (Pro Ultra ENDO Tips, DENTSPLY Tulsa Dental, Tulsa, Oklahoma) were used around the fragment to expose it, and then ultrasonic activation with ultrasonic tips were applied to remove the fragment that makes the fragment loosen now the fractured fragment was removed using H file which was approximately 3mm in length (Fig. 2 & 3). The patency of the canal was checked using magnifying loupes. Multiple radiographs in different angulations were taken; working length was determined using electronic apex locator. Cleaning and shaping was done using WaveOne Gold. Irrigation was performed with 3% sodium hypochlorite solution. Calcium hydroxide paste was used as an intra-canal medicament.

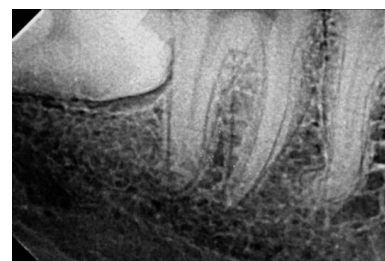
**Fig. 3: Intra Oral periapical radiograph showing retrieval of separated instrument**

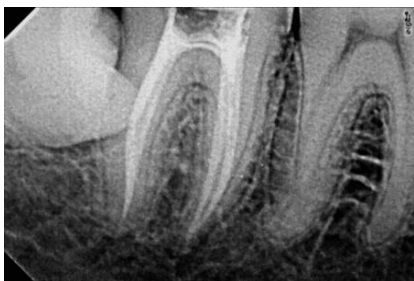
**Fig. 5: Intra Oral periapical radiograph showing Obturation**

In second appointment, Calcium hydroxide paste was removed using normal saline & Canals were then irrigated with 17% aqueous EDTA solution as a final flush. Root canals were obturated with gutta-percha and AH Plus sealer using warm vertical compaction technique (Fig. 4 & 5). The tooth was subsequently restored. Follow up was done for 6 months and the patient was found to be clinically asymptomatic (Fig. 6).
