Content available at: <https://www.ipinnovative.com/open-access-journals>

IP Indian Journal of Conservative and Endodontics

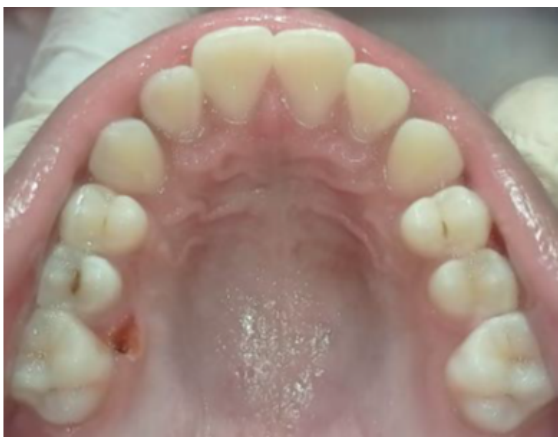
**Figure 1:** Maxillary arch

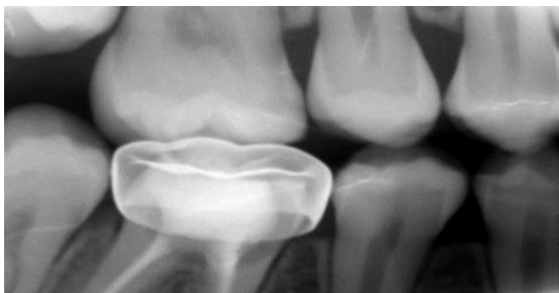
**Figure 7:** Stainless steel crown placedwrt 46

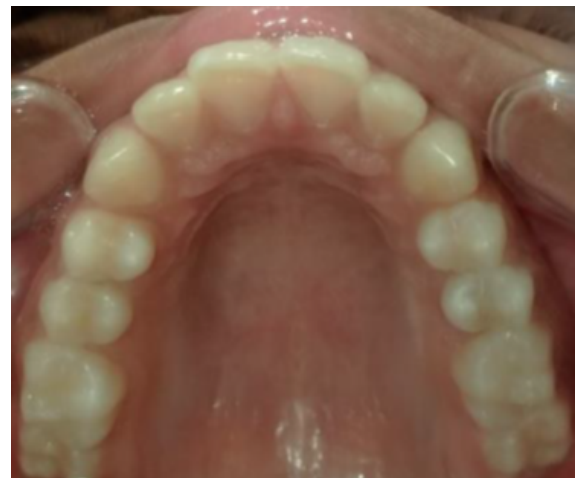
**Figure 9:** Maxillary arch
