Use of novel method of fibersite preshaped abutment post for the aesthetic treatment of severely compromised maxillary central incisor with 1 year follow-up a case report

Shaik Izaz^{1,*}, Bolla Nagesh², Bhargavi Dasari³, Prasanna Sirla⁴, Mallikarjun Elaparolu⁵

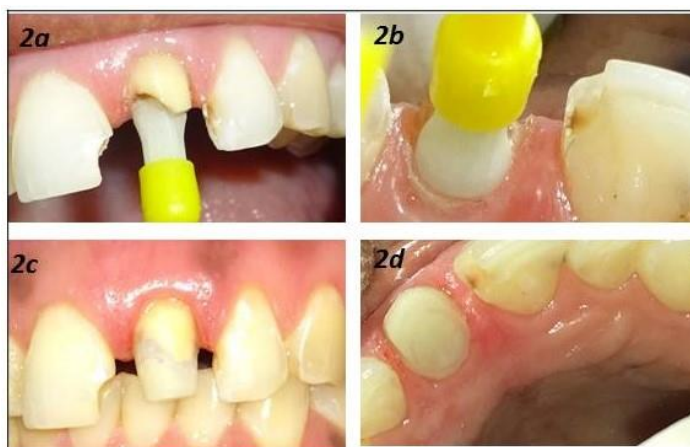
Fig.2

- 2a, 2b: Buccal and palatal intra oral view of maxillary left central incisor with fibersite post check-in
 2c, 2d: Immediate post-operative intra-oral view of maxillary left central incisor with core build-up

The crown build was done with flowable composite to reach all the discrepancies and remaining was restored with nano-filled composite (Filtek™ Z250XT Nano Hybrid Universal Restorative) [Fig.2c, 2d, 3d]. Crown preparation was done and impressions were registered. Single unit porcelain fused metal ceramic crown was fabricated and cemented [Fig.3e]. 1 year follow-up IOPAR [Fig. 3f]

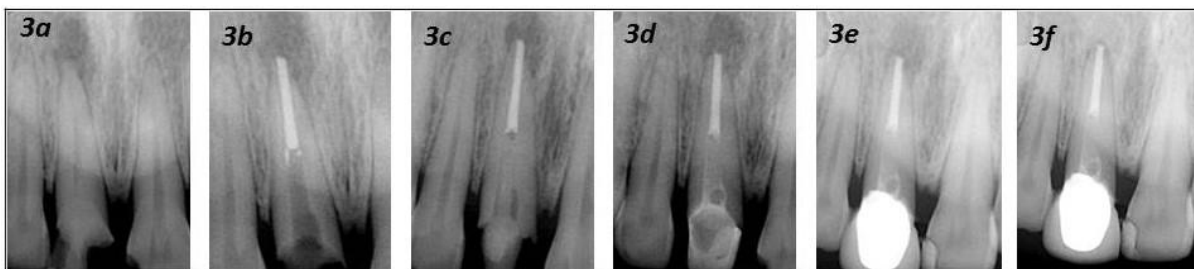
Fig. 3

- 3a: Pre-operative intra-oral IOPAR
- 3b, Post space preparation with no:2, 3 gates gilliden drills and Special guide drill provided by manufacturer
- 3c: Fibersite post check-in done
- 3d: Immediate post-operative IOPAR with post cementation and core build-up
- 3e: Post-operative IOPAR with crown
- 3f: 1 year follow-up IOPAR
